Bankers Trust

Figure 6-10 Area of collapsed floor slab in bays between C-8, E-8, C-7, and E-7, from the 15th floor.

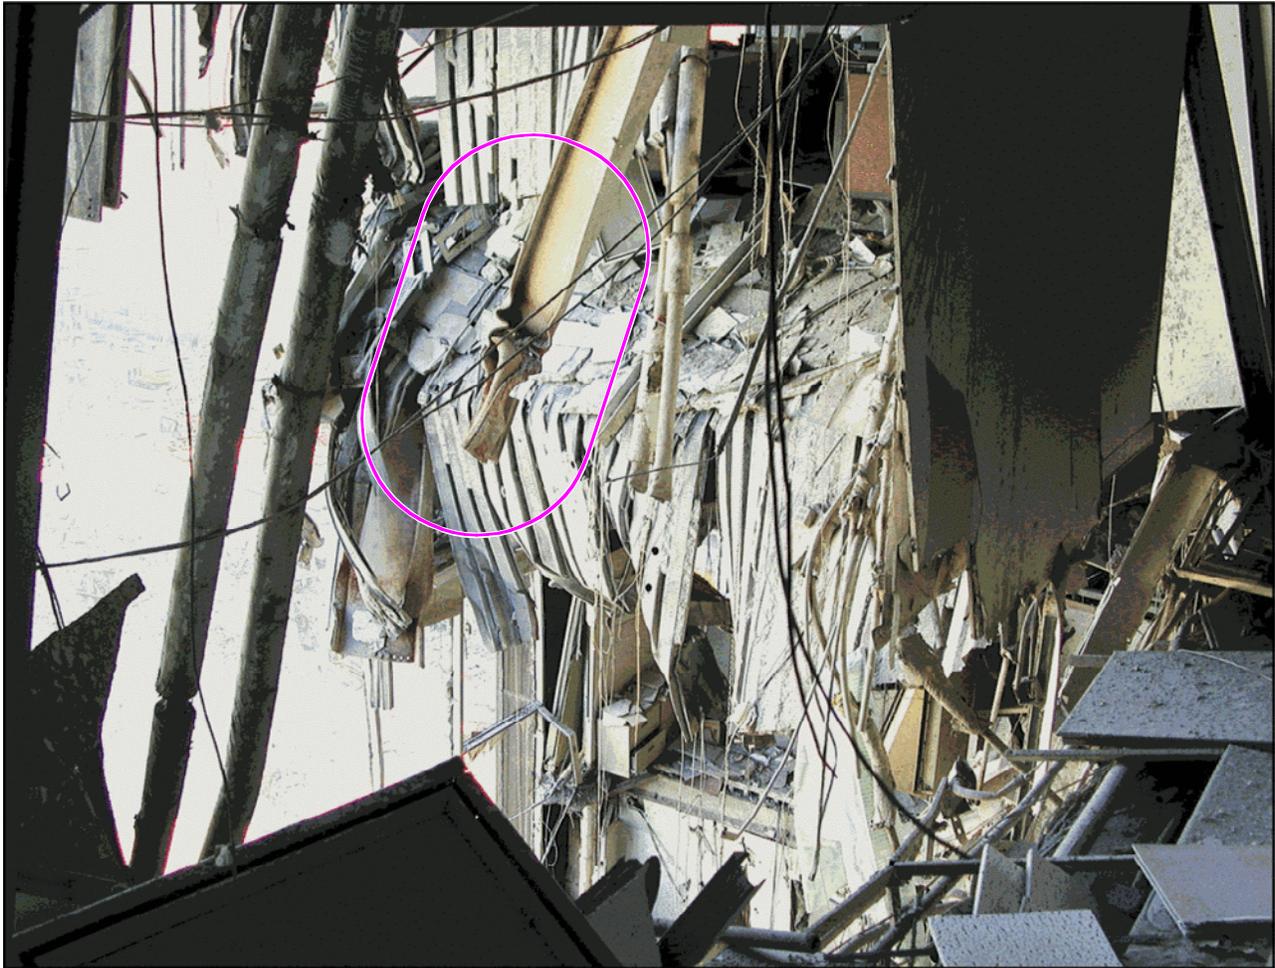
Figure 74. (Fig6-10.) from the FEMA report . This beam shriveled up and has see-through holes in it, hanging in the gash/opening of Bankers Trust.

If the random deformation shown in Figures 74 and 76 were caused by heat, the paint would be burnt off.

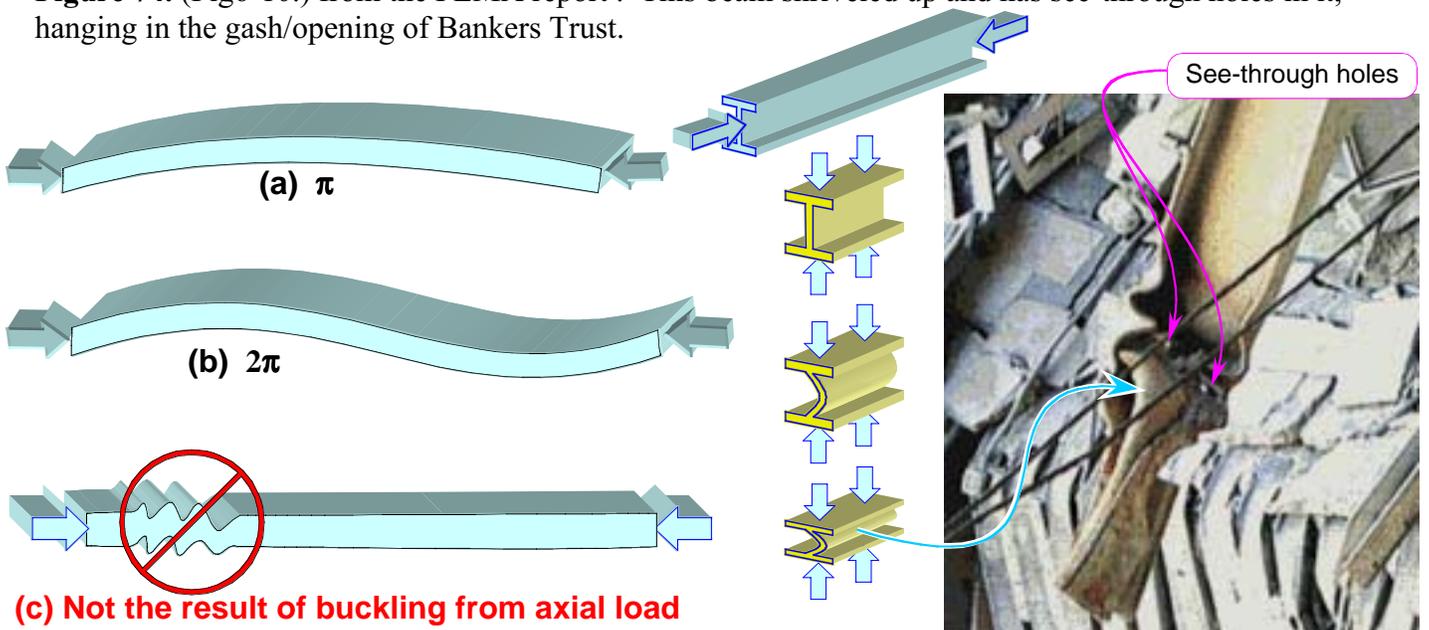
(c) Not the result of buckling from axial load

Figure 75. In buckling a beam deforms into (a) a half sine wave, π , or (b) a full sine wave, or 2π . The random deformation in (c) is not associated with buckling.

Figure 76. A close-up view of an I-beam in Figure 74.

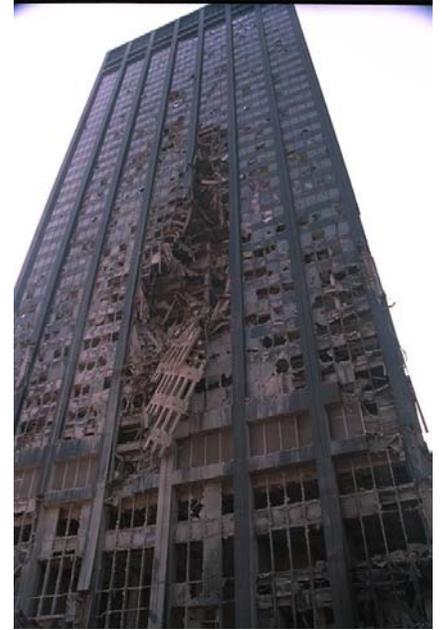
Figure 79. Bankers Trust

8. There is no obvious cause of the gash in Bankers Trust (BT). The wheatchex hanging from the gash did not make the gash that is several times wider and deeper and taller than the wheatchex. Also the wheatchex shows little or no apparent damage.

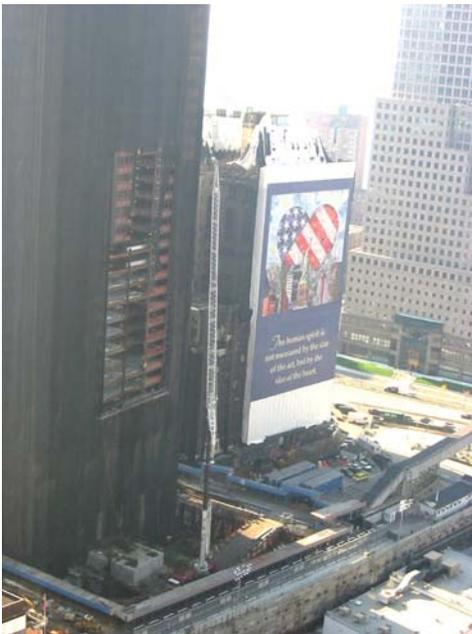
Figure 80. Two years after 9/11 the missing floors are being replaced. (brightness, contrast, adjusted)
(11/3/03)

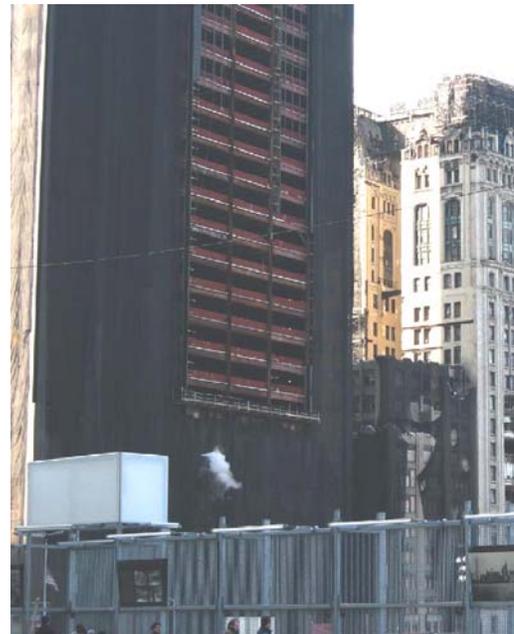
Figure 81. Floors restored in early 2004.
(brightness, contrast, adjusted)

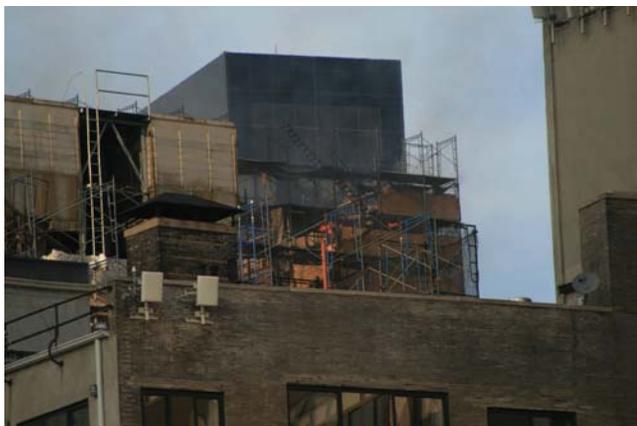
Figure 84. Fire at the Bankers Trust building,
August 2007.
(8/07)

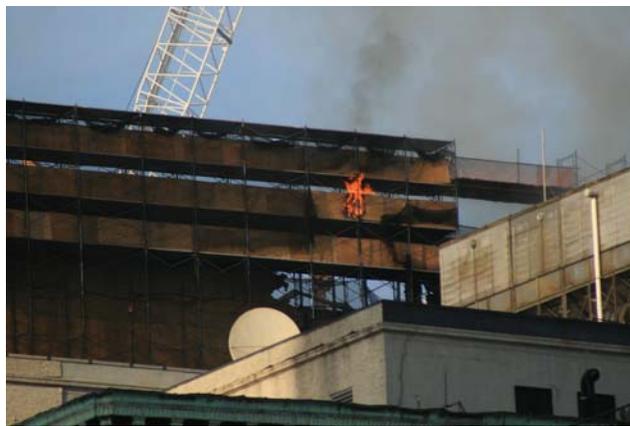
Figure 85. Fire at the Bankers Trust building,
August 2007. The steel appears to be on fire
more than the wood does. Also, there is a relative
lack of smoke coming from those flames.
(8/07)

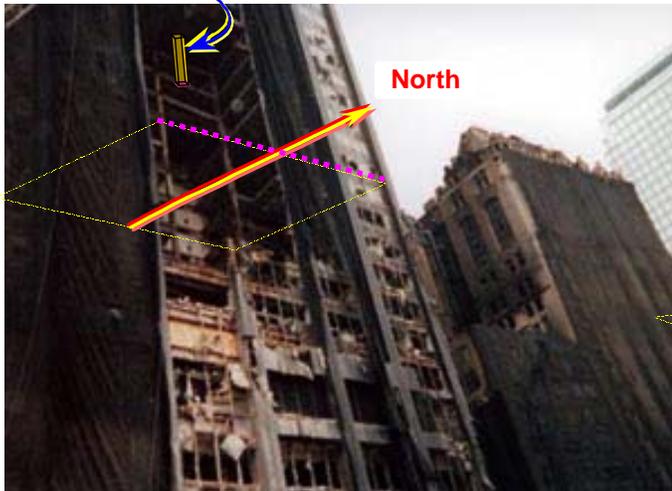
Approximate location of the "furry" rusted beam in Figures 87 and 88.

Figure 86. Photo of Bankers Trust, soon after 9/11. (09/01) Source:

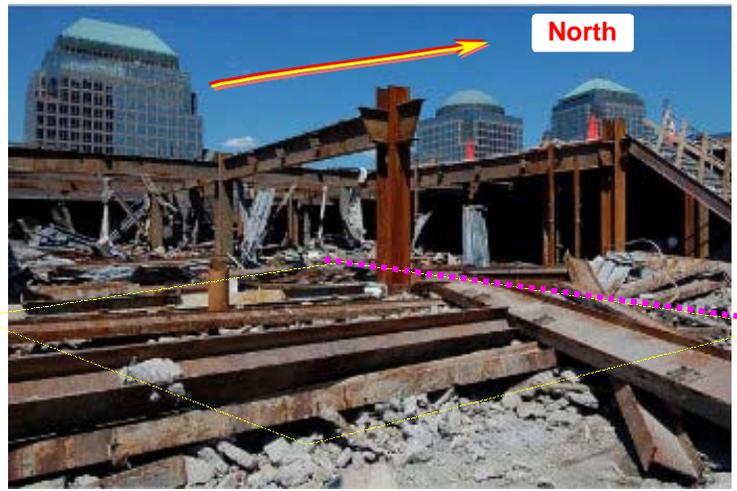
Figure 87. This is Bankers Trust being taken apart. Floors have been removed down to approximately the elevation shown in Figure 86. The very rusty beam (furry-rust) is approximately in the location shown in Figure 86. Recognize any "rustification" out there?

10. The rusty column near the center of Figure 87 is incredible! How many years at the bottom of the ocean would be required to do that? Normally, steel beams do not exhibit such rapid "rustification."

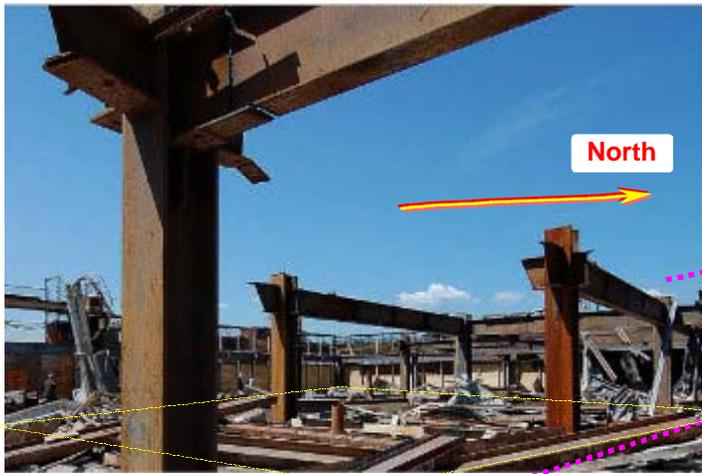
Figure 88. As more and more beams and columns are removed, what was once an enclosed building opens up to the sky.

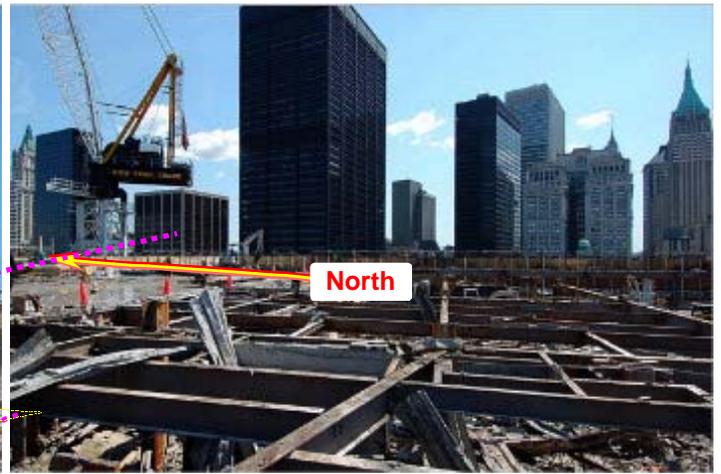
Figure 89. Once the concrete slab and metal decking are removed, what remains is a steel skeleton of each floor. There is little rust in the southwest corner of the building, even though it is open during the deconstruction from the top down.

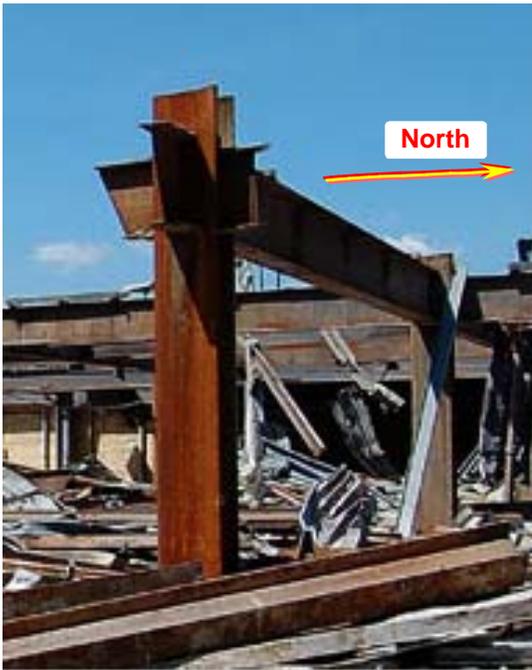
Figure 90. Close-up of Figure 88. As more and more beams and columns are removed, what was once an enclosed building opens up to the sky. (*brightness, contrast, adjusted*)

11. Figures 90 and 91 are in the area of where the big gash was repaired. The replacement beams were presumably new, yet they are already thick with rust as located in the diagram below.

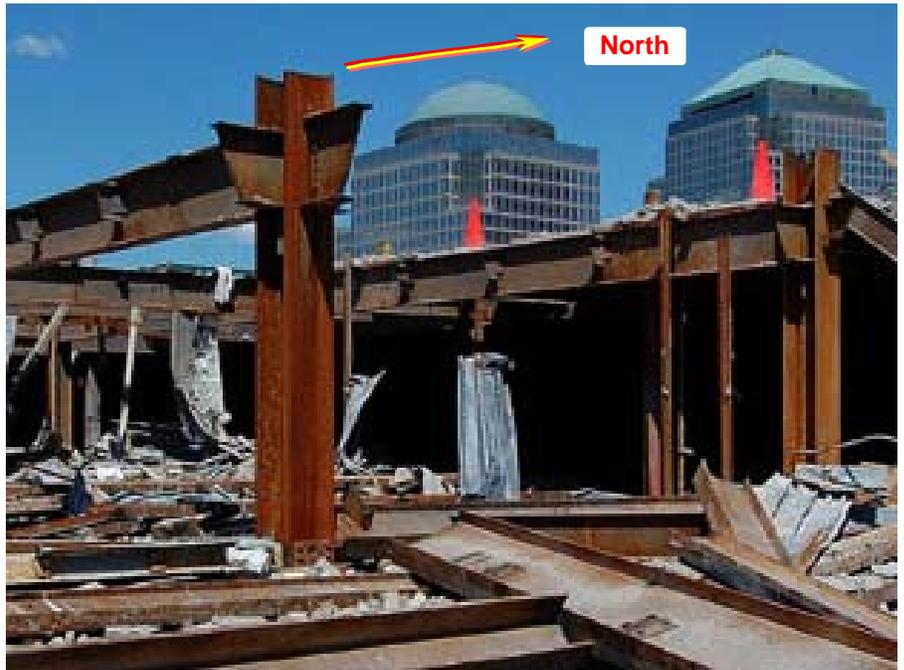
Figure 91. Close-up of Figure 87. This is Bankers Trust being taken apart. Recognize any "rustification" out there? (*brightness, contrast, adjusted*)

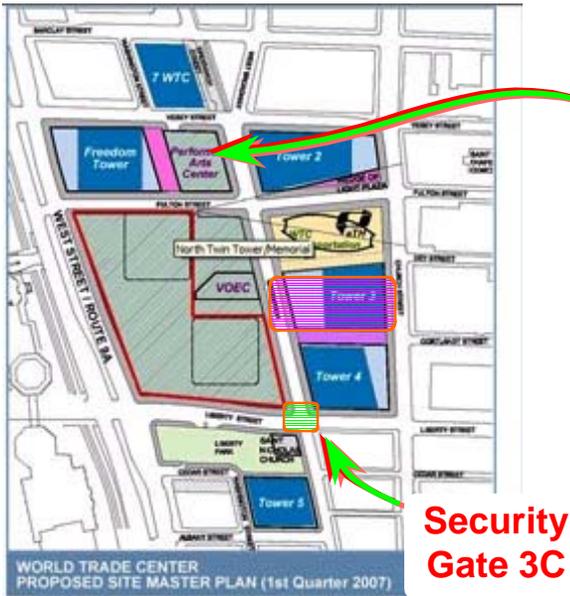
Figure 92. The old PATH train station used to be below the area between the original WTC 4 & 5 and Surfaces where beams were stacked leave silhouettes of where the new Tower 3 is, including adjacent areas. rust.
(01/07)

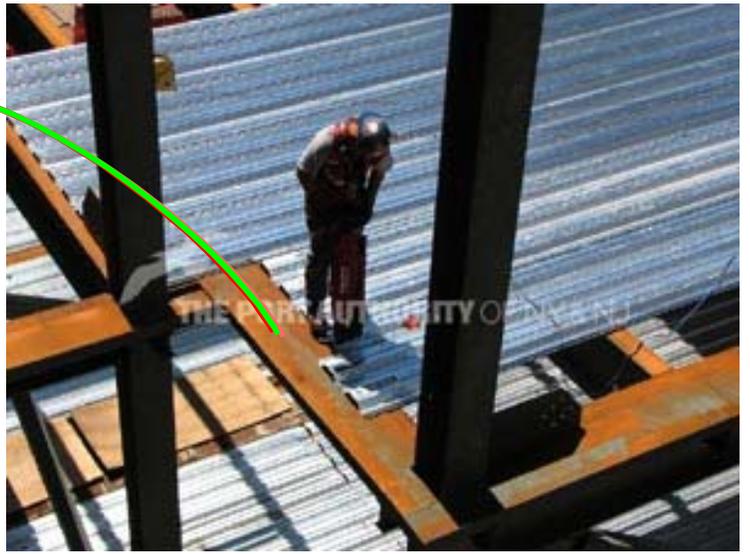
Figure 93. The rust forms before the beams are in place. Surfaces where beams were stacked leave silhouettes of where the new Tower 3 is, including adjacent areas. rust.
(07/07)

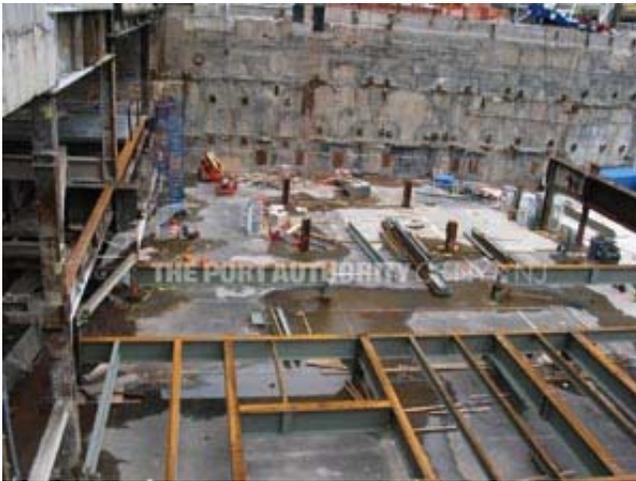
Figure 94. Rust appears very quickly in some areas and not others.
(06/07)

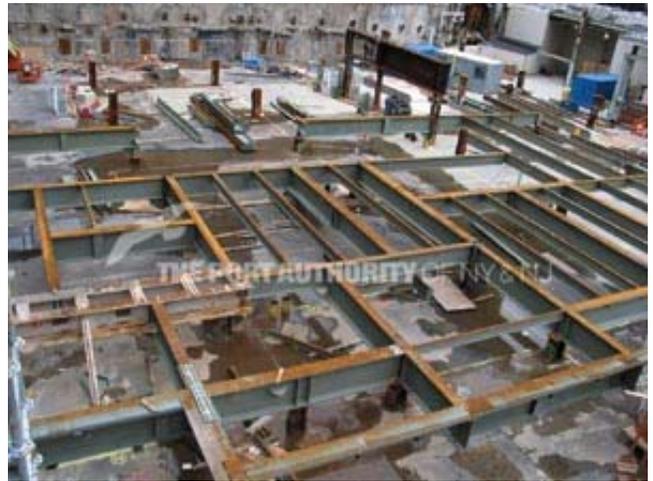
Figure 95. Rust appears very quickly in some areas and not others.
(06/07)

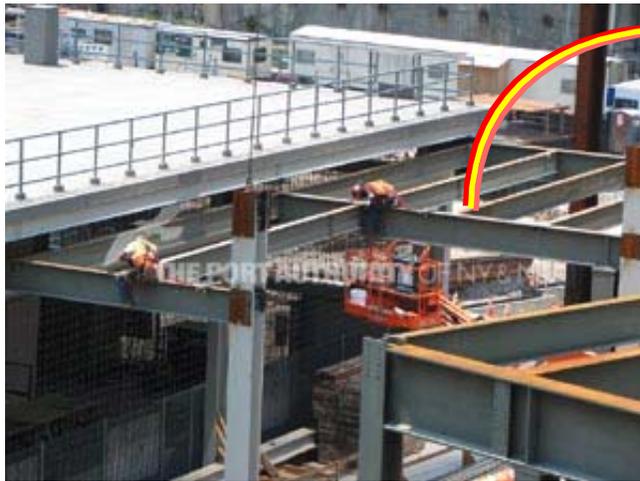
Figure 96. Beams rust before they are put in place. (06/07)

13. New beams. Nearly instantaneous rust. This is not normal, especially for treated and painted beams of structural steel. This is the kind of rust you might expect to see in an iron skillet left in standing water.

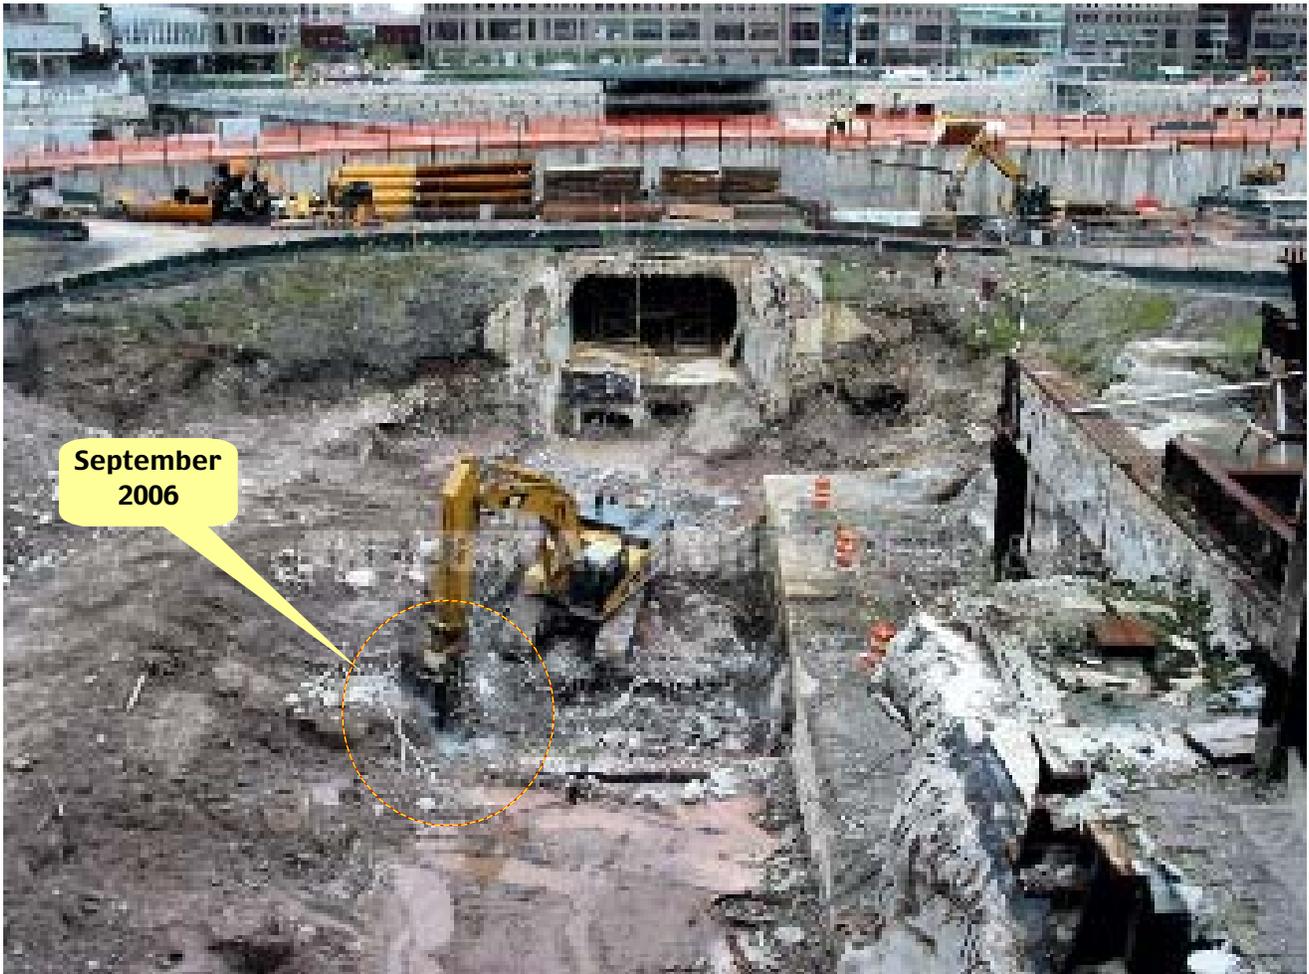
Figure 100. A view west along where the PATH train tracks were. Stirring the mud triggers fuming five years after 9/11. The fuming emerges from saturated dirt/mud.
(9/06)

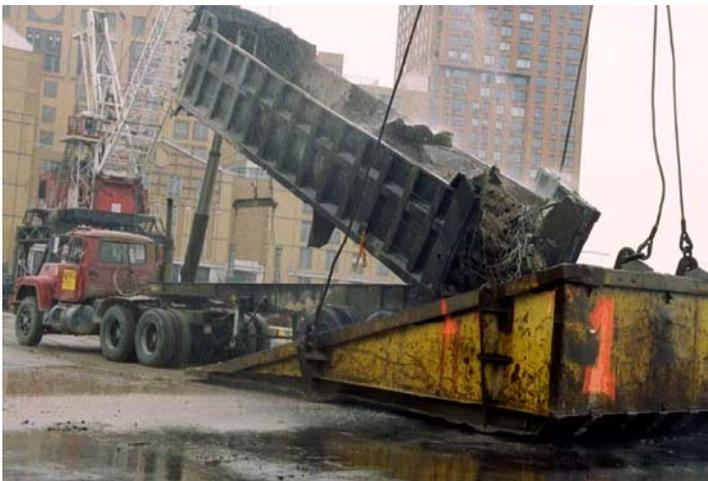
Figure 101. March 15, 2002, a truck dumps fuming dirt into the bucket of a 500-ton floating crane located at FEMA's Pier 25 loading site, a few blocks north of Ground Zero. The fuming dirt is sprayed with water.
(3/15/02)

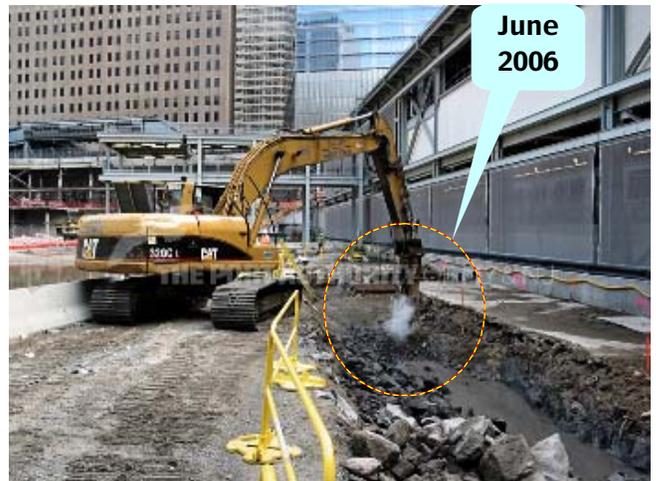
Figure 102. June 2006, looking north in the big bathtub. The new WTC7 is in the distance, on the right. Here's why the dirt is needed. This is the same "puff-ball poofing" I saw in October!
(6/06)
