Why Indeed Did the WTC Buildings Collapse?

By Steven E. Jones

Department of Physics and Astronomy

Brigham Young University

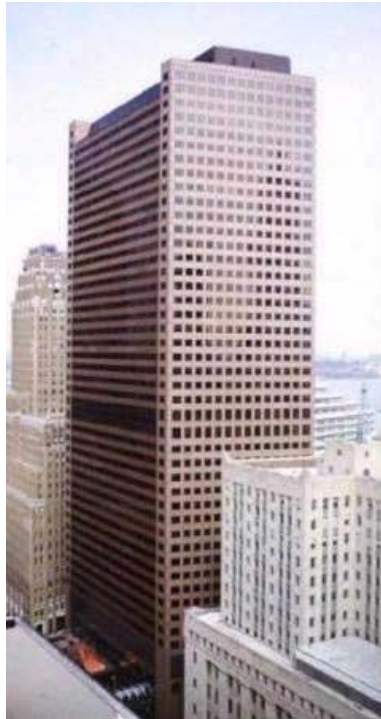
WTC 7: 47 - Story, steel-frame building..

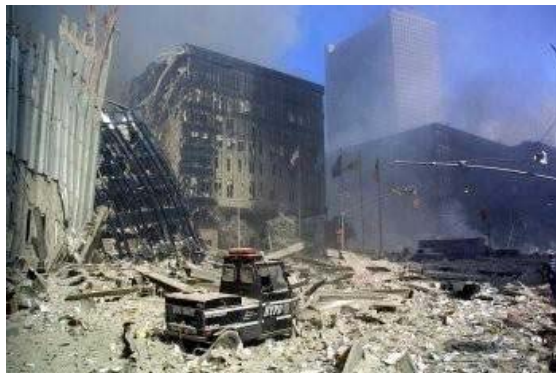
WTC 7 on afternoon of 9-11-01. WTC 7 is the tall sky-scraper in the background, right. Seen from WTC plaza area.

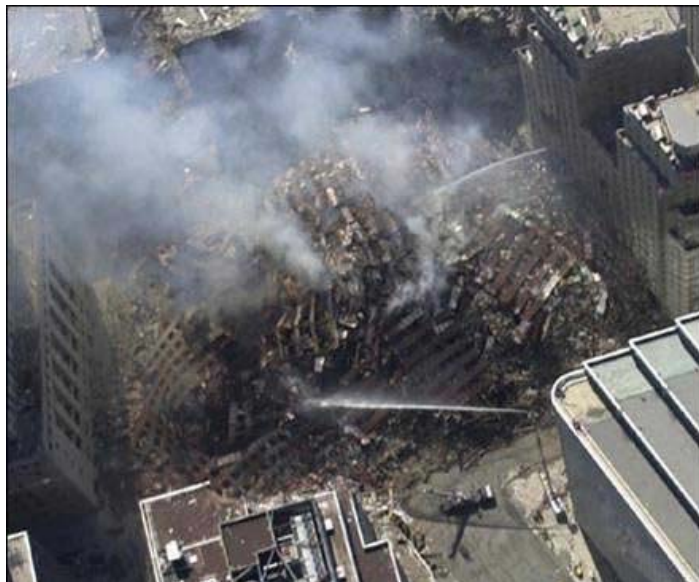
WTC 7 collapsed completely, onto its own footprint

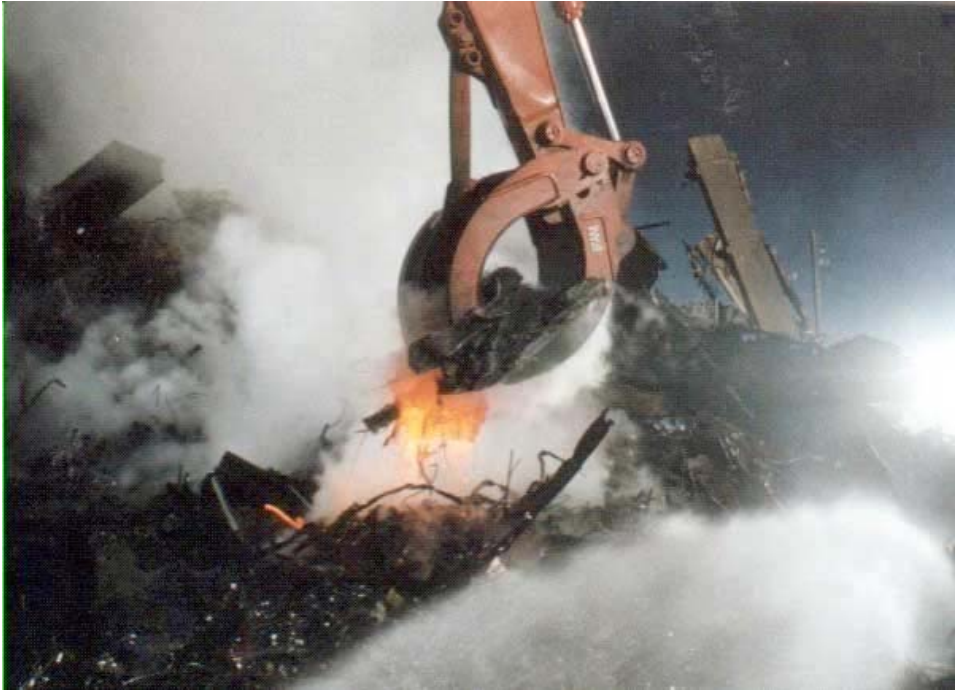
We see from the photograph above that solid metal from the WTC rubble existed at salmon-to-yellow-hot temperature (approx. 1550 - 1900 oF, 845 - 1040 oC.) The temperature is well above the melting temperatures of lead and aluminum, and these metals can evidently be ruled out since they would be runny liquids at much lower (cherry-red or below) temperatures. However, the observed hot specimen could be structural steel (from the building) or iron (from a thermite reaction) or a combination of the two. Additional photographs of the hot metal could provide further information and advance the research.

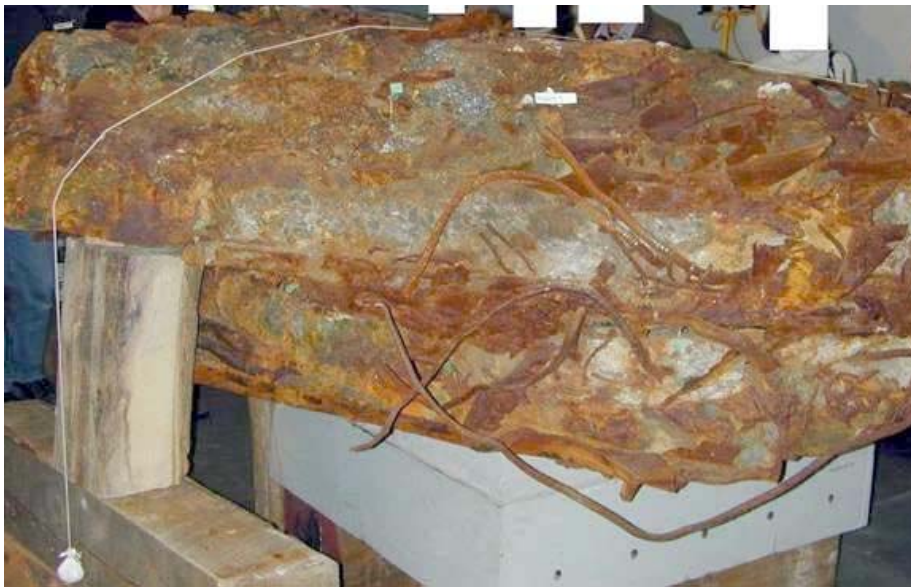
The following photograph has become available, evidently showing the now-solidified metal with entrained material, stored (as of November 2005) in a warehouse in New York:

The abundance of iron (as opposed to aluminum) in this material is indicated by the reddish rust observed. When a sample is obtained, a range of characterization techniques will quickly give us information we seek. X-ray energy dispersive spectrometry (XEDS) will yield the elemental composition, and electron energy-loss spectroscopy will tell us the elements found in very small amounts that were undetectable with XEDS. Electron-backscattered diffraction in the scanning electron microscope will give us phase information; the formation of certain precipitates can tell us a minimum temperature the melt must have reached. We will endeavor to obtain and publish these data, whatever they reveal. An intriguing photograph (below right) taken by Rob Miller, photojournalist with the New York Post, provides

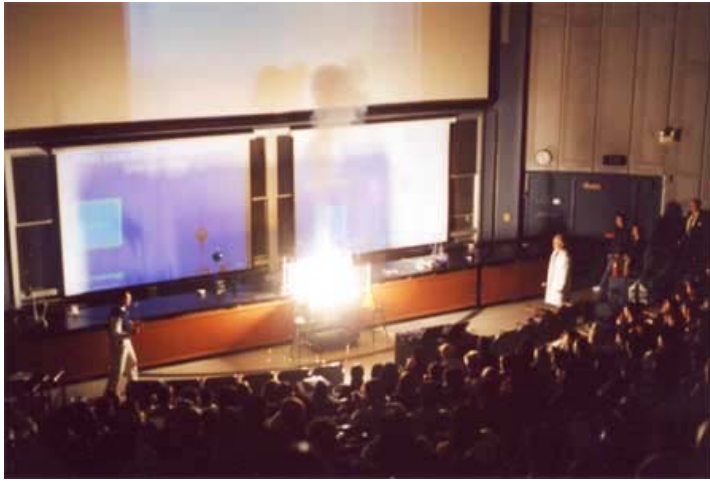
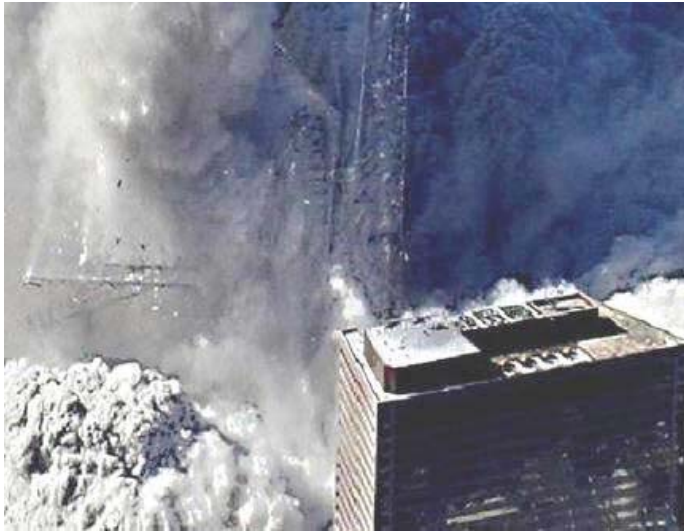
additional photographic evidence (Swanson, 2003) for the use of thermite or a sulfur-containing derivative such as thermate. We see debris and dust as WTC 1 collapses, with WTC 7 seen in the foreground, across the street from WTC 1. The photograph on the left shows, for comparison, the thermite reaction with a grayish-white aluminum-oxide dust plume extending upwards from the white-hot molten iron "blob" from the reaction (<http://www.cchem.berkeley.edu/demolab/images/ironred.jpg>).

Mr. Miller captured two ladder-like structures in his photograph (middle left of the right-most photograph above; a cleaner photo is being sought), consistent with steel structures observed in the core of WTC 1. Observe the grayish-white plumes trailing upward from white "blobs" at the left-most extremities of the upper structure. (The lower structure is mostly obscured by dust.) It is possible that thermite cut through structural steel and that what we now observe is white-hot iron from the reaction adhering to the severed ends of the steel, with grayish-white aluminum oxide still streaming away from the reaction sites. The observations are *consistent with the use of thermite or one of its variants*. However, further analysis of this and additional photographs from the series is necessary before any firm conclusions can be drawn about this line of evidence.

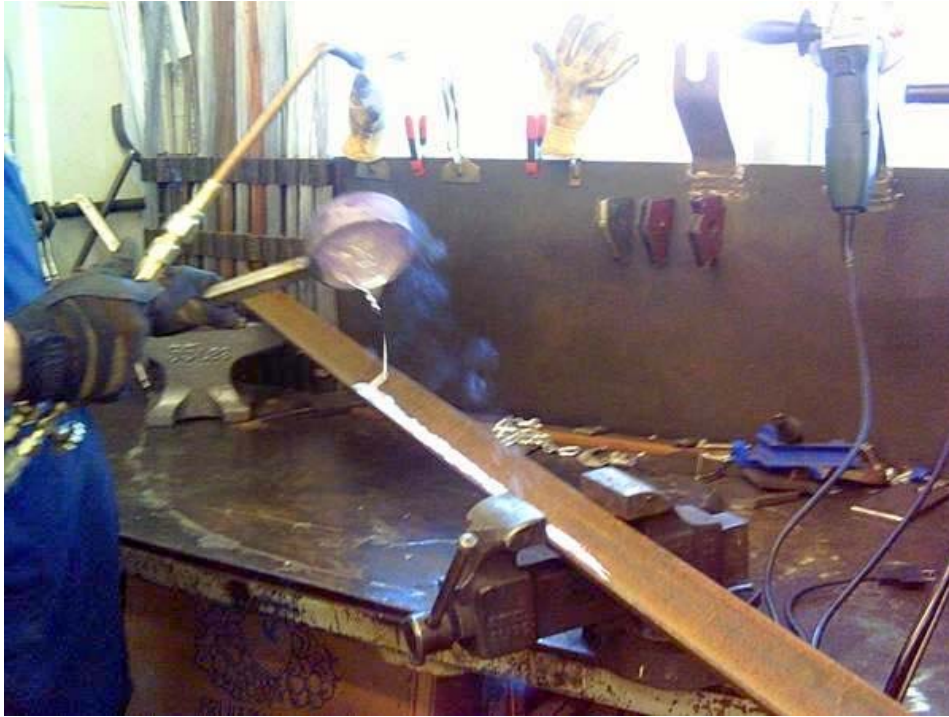
Molten aluminum poured onto rusted steel: no violent reactions observed at all.

We also noted that while a steel pan holding the aluminum glowed red and then yellow hot, the molten aluminum inside retained its silvery-gray color, adding significantly to the evidence that the yellow-white molten metal dripping from the South Tower shortly before its collapse was NOT molten aluminum. (Recall also that the yellow color of the molten metal (video clip above) implies a temperature of approximately 1100 oC — too high for the dark-smoke hydrocarbon fires burning in the building.) This is point worth emphasizing: aluminum has low emissivity and high reflectivity, so that in daylight conditions molten aluminum will appear silvery-gray, while molten iron (with its characteristic high emissivity) will appear yellow-white (at ~1100 oC) as observed in the molten metal dripping from the South Tower just before its collapse (see <http://www.checktheevidence.com/911/Thermite2.htm>).

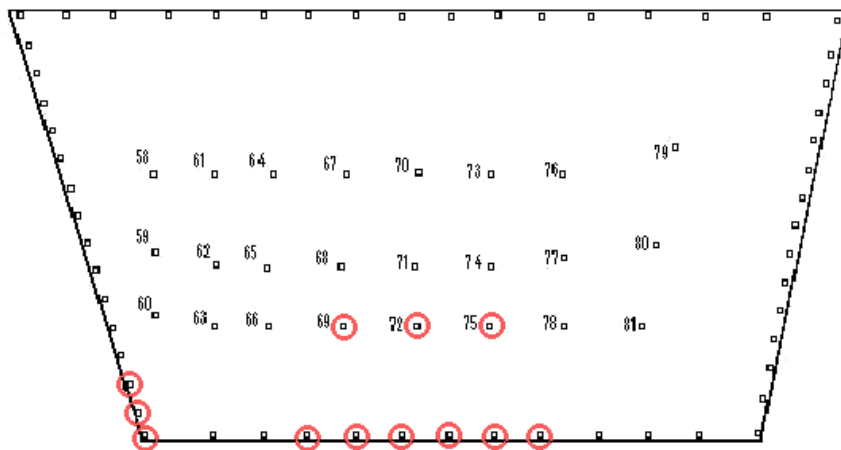
Diagram showing steel-column arrangement in WTC 7, view looking down on the roof. Circled columns were possibly damaged due to debris from WTC 1 collapse, some 350 feet away (NIST, 2005) so the damage was clearly non-symmetrical, and evidently, none of the core columns was severed by falling debris. WTC 7 was never hit by a plane.

As you observed (link above), WTC 7 collapsed rapidly and nearly-straight-down symmetrically — even though fires were randomly scattered in the building. WTC 7 fell about seven hours after the Towers collapsed, even though no major persistent fires were visible. There were twenty-four huge steel support columns inside WTC 7 as well as huge trusses, arranged non-symmetrically, along with some fifty-seven perimeter columns, as indicated in the diagram below (FEMA, 2002, chapter 5; NIST, 2005).

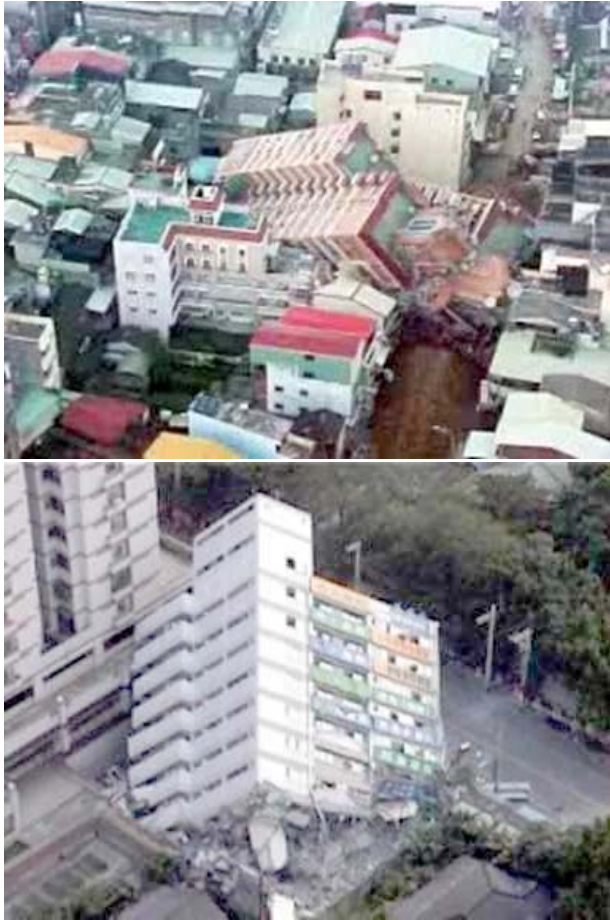
Non-symmetrical collapse of tall buildings, consistent with the Law of increasing entropy when due to random causes (approximately 9+ stories, here due to earthquakes).

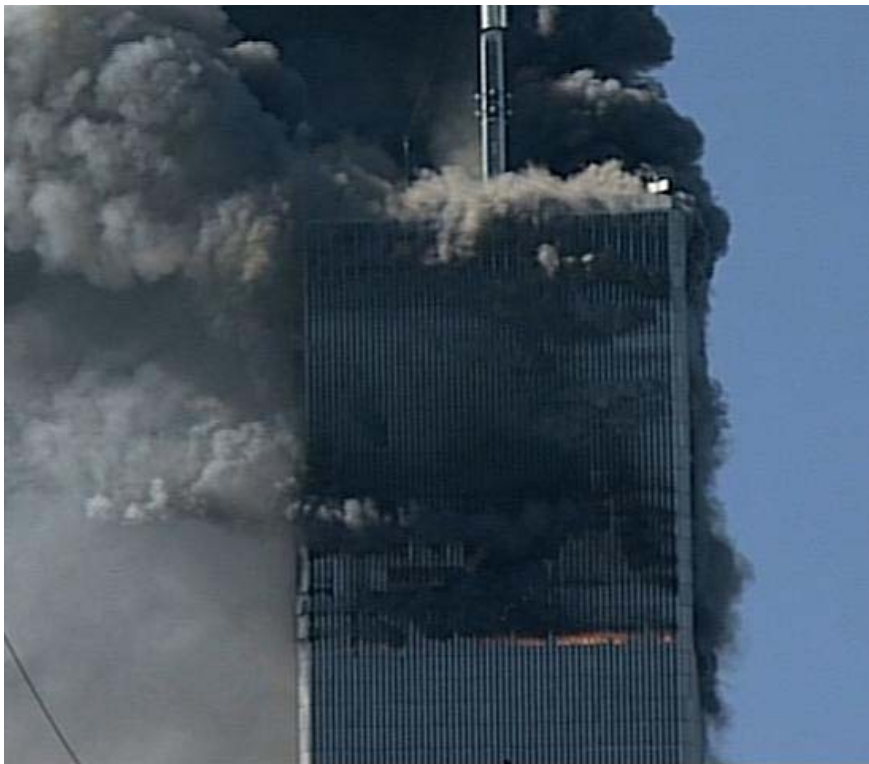
North Tower showing antenna (top) at beginning of collapse.

The official FEMA 9-11 report admits a striking anomaly regarding the North Tower collapse: Review of videotape recordings of the collapse taken from various angles indicates that the transmission tower on top of the structure began to move downward and laterally slightly before movement was evident at the exterior wall. This suggests that **collapse began with one or more failures in the central core area of the building.** (FEMA, 2002, chapter 2; emphasis added.)

Yes, we can see for ourselves that the antenna drops first from videos of the North Tower collapse. (See http://911research.wtc7.net/wtc/evidence/videos/wtc1_close_frames.html; also <http://home.comcast.net/~skydrifter/collapse.htm>.) A NY Times article also notes this behavior:

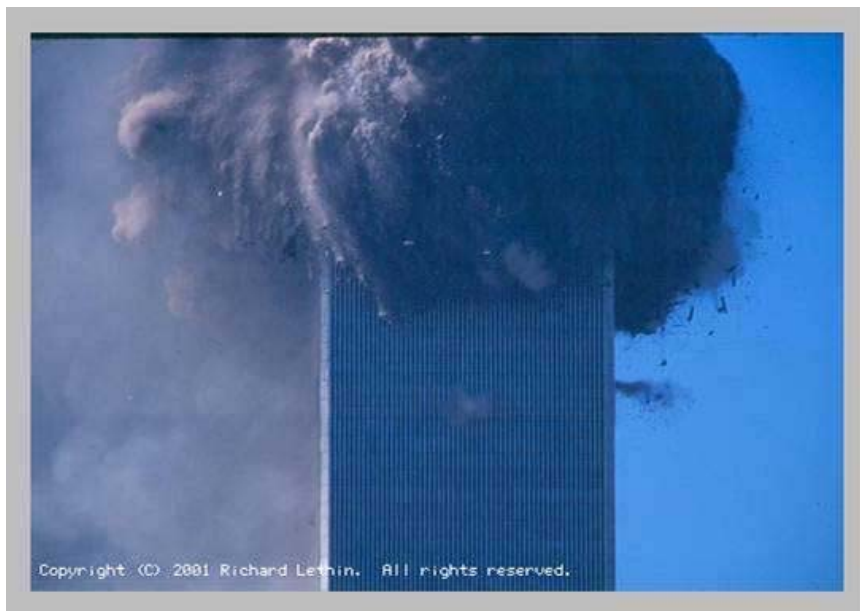
North Tower during top-down collapse.
Notice mysterious horizontal plumes far below pulverization region.

The horizontal ejection of structural steel members for hundreds of feet and the pulverization of concrete to flour-like powder, observed clearly in the collapses of the WTC towers, provide further evidence for the use of explosives – as well-explained in <http://911research.wtc7.net/talks/towers/index.html>. (See also, Griffin, 2004, chapter 2.) The observed plumes or “squibs” are far below the pulverization region and therefore deserving of particular attention. They appear much like the plumes observed in <http://www.implosionworld.com/cinema.htm> (e.g., the controlled demolition of the Southwark Towers).

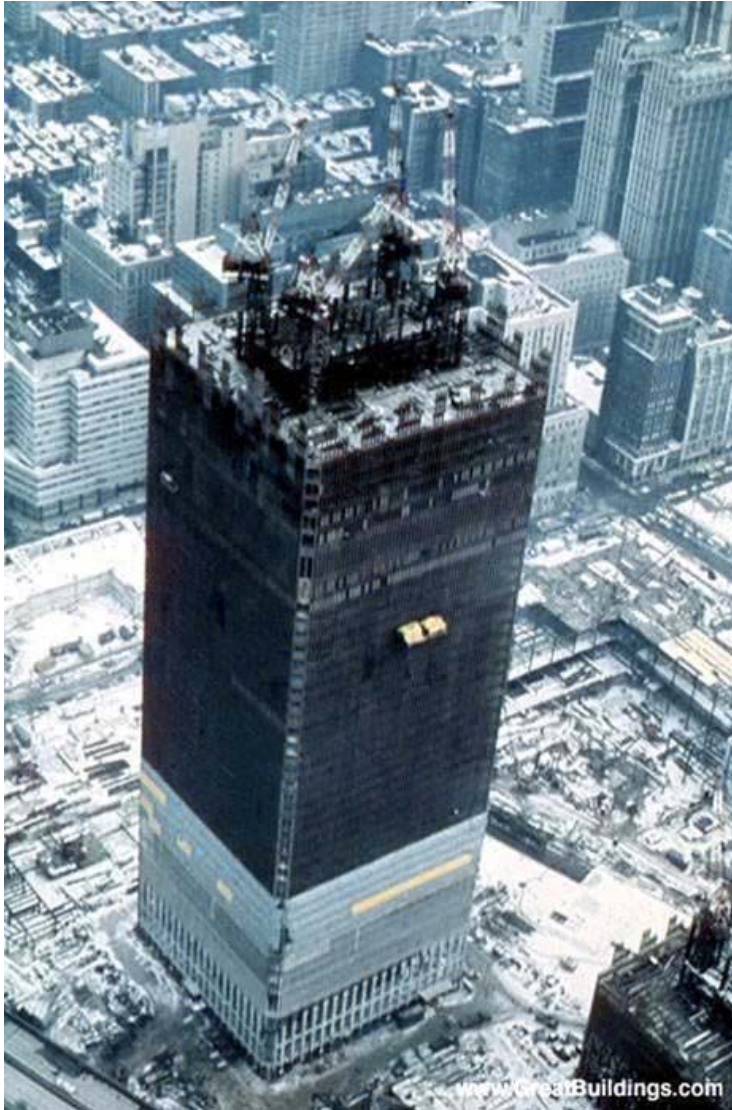
The WTC towers were solidly constructed with 47 steel core columns and 240 perimeter steel columns. 287 steel-columns total. Many doubt that random fires/damage could cause them to collapse straight down (official theory), and suspect explosives.

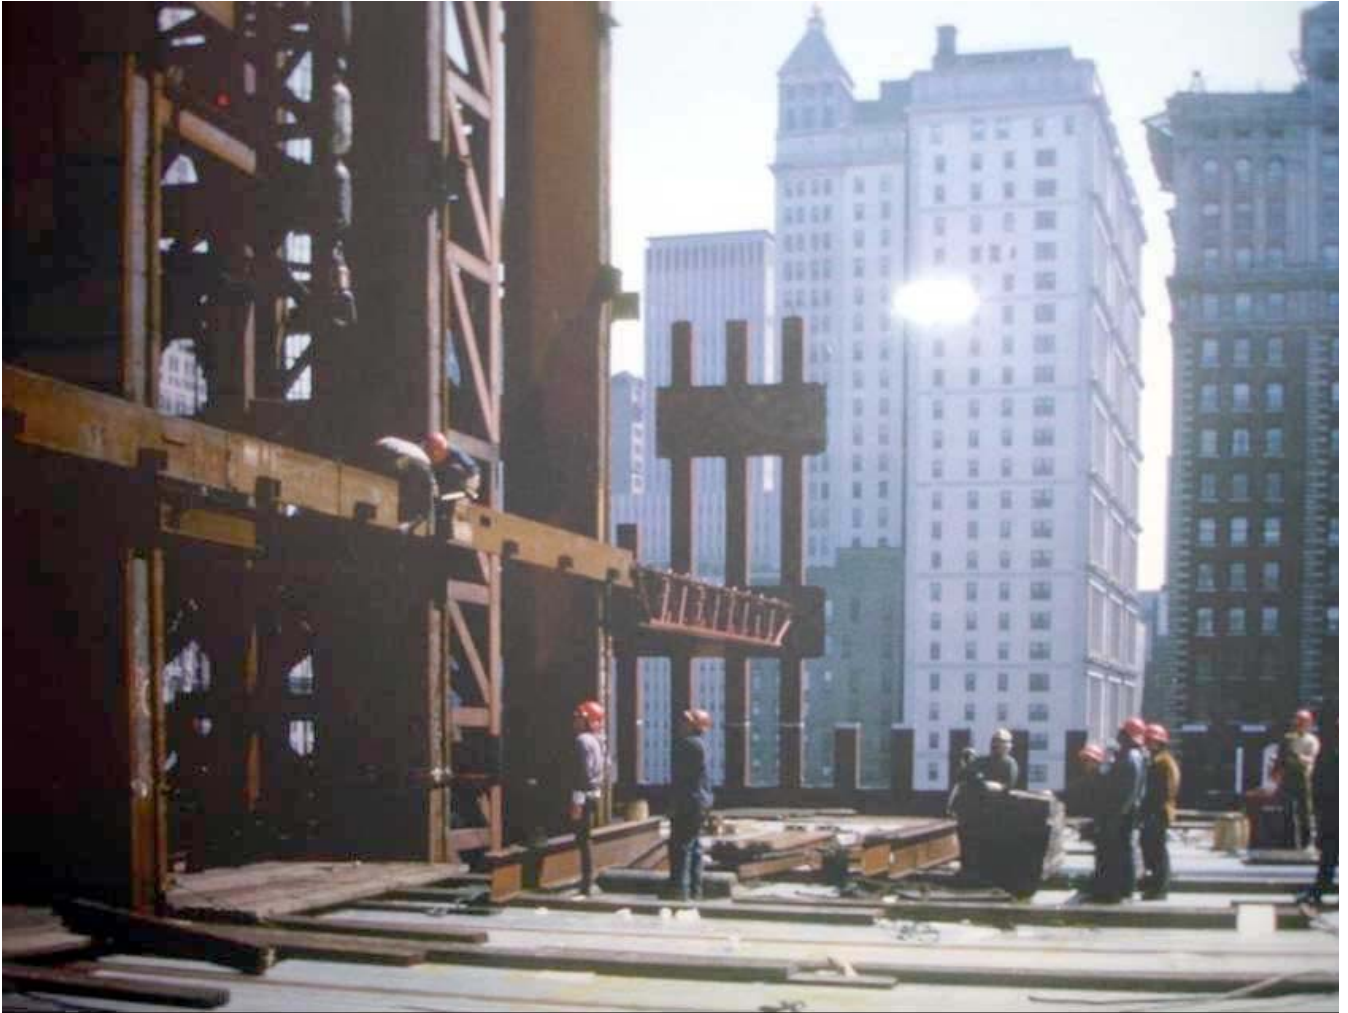
Steel-frame: Huge core (left) is an enormous heat sink. Notice workers standing on floor pan which is firmly attached to the interconnected core columns.

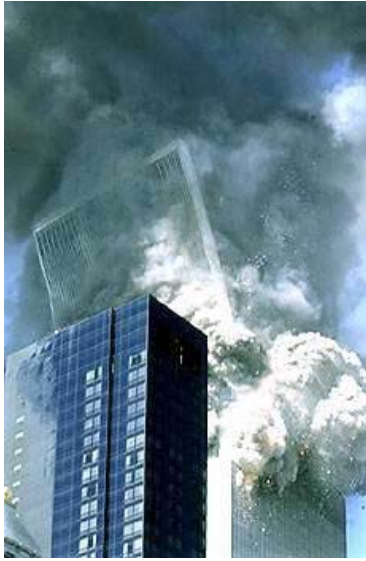
Top ~ 30 floors of South Tower topple over.
What happens to the block and its angular momentum?

We observe that approximately 30 upper floors begin to rotate as a block, to the south and east. They begin to topple over, as favored by the Law of Increasing Entropy. The torque due to gravity on this block is enormous, as is its angular momentum. But then – and this I’m still puzzling over – this block turned mostly to powder in mid-air! How can we understand this strange behavior, without explosives? Remarkable, amazing – and demanding scrutiny since the US government-funded reports failed to analyze this phenomenon. But, of course, the Final NIST 9-11 report “**does not actually include the structural behavior of the tower after the conditions for collapse initiation were reached.**” (NIST, 2005, p. 80, fn. 1; emphasis added.)
