## Why Indeed Did the WTC Buildings Collapse?

By Steven E. Jones

Department of Physics and Astronomy

### ABSTRACT

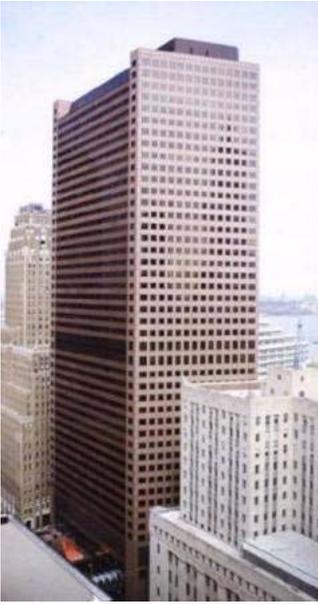
WTC 7: 47 - Story, steel-frame building..

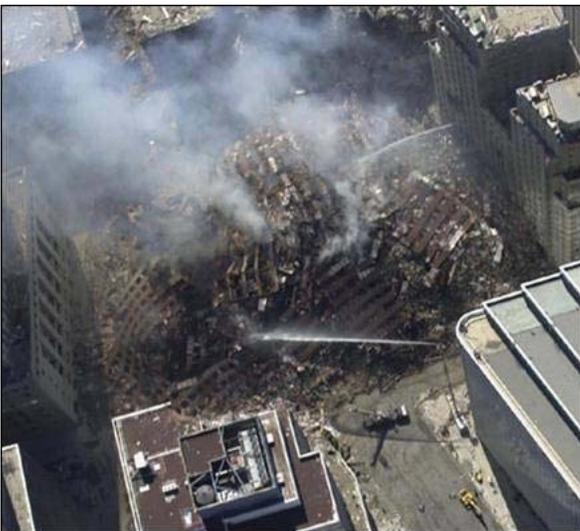
WTC 7 collapsed completely, onto its own footprint

Careful observation of the collapse of WTC 7 (video clips above) demonstrates a downward "kink" near the center of the building first, suggesting "pulling" of the support columns, then the building's sides pull inward such that the building "collapses straight down into its own footprint" (Harris, 2000). The plumes of debris observed on upper floors of WTC 7 as the collapse begins appear consistent with explosive cutting of supports for "a few upper stories" as outlined above. FEMA admitted that WTC 7 collapsed onto a well-confined footprint:

**The collapse of WTC 7 had a small debris field as the facade was pulled downward, suggesting an internal failure and implosion...** The average debris field radius was approximately 70 feet. (FEMA, 2002, chapter 5.)

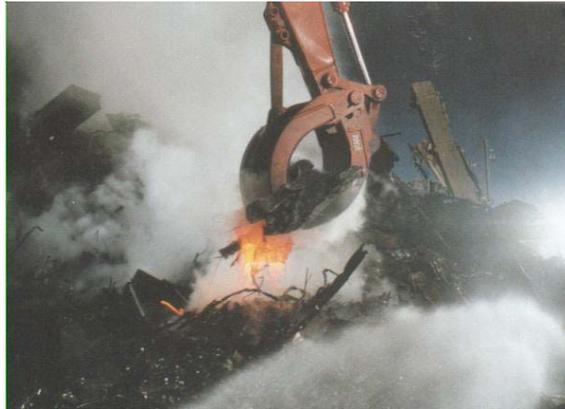
We see from the photograph above that solid metal from the WTC rubble existed at salmon-to-yellow-hot temperature (approx. 1550 - 1900 °F, 845 - 1040 °C.) The temperature is well above the melting temperatures of lead, zinc and aluminum, and these metals can evidently be ruled out since they would be runny liquids at much lower (cherry-red or below) temperatures. However, the observed hot specimen could be structural steel (from the building) or iron (from a thermite reaction) or a combination of the two. Additional photographs of the hot metal could provide further information and advance the research.

Even without a direct elemental analysis, we can rule out some metals based on available data. The photograph in the introduction shows a chunk of hot metal being extracted at ground zero. The hottest portion of the chunk is the lower portion, which was deepest down in the slag, and the metal is seen to be yellow-hot, certainly above cherry-red hot. The following table (see <http://www.processassociates.com/process/heat/metcolor.htm>) provides data regarding the melting temperatures of lead, aluminum, structural steel and iron, along with approximate metal temperatures by color. Note that the approximate temperature of a hot metal is given by its color, quite independent of the composition of the metal. (A notable exception is aluminum, which due to low emissivity and high reflectivity appears silvery-gray in daylight conditions, at all temperatures whether in solid or liquid forms. Aluminum does incandescence like other metals, but faintly, so that in broad daylight conditions in air, it appears silvery-gray according to experiments done at BYU. [Jones, 2006])

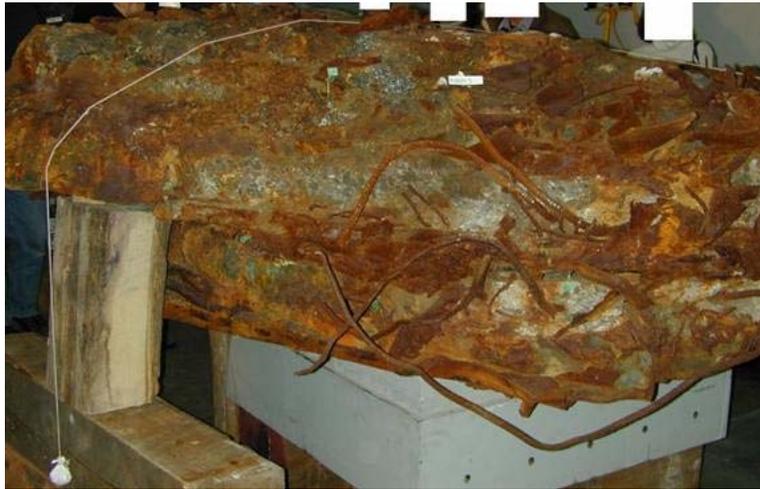
The abundance of iron (as opposed to aluminum) in this material is indicated by the reddish rust observed. When a sample is obtained, a range of characterization techniques will quickly give us information we seek. X-ray energy dispersive spectrometry (XEDS) will yield the elemental composition, and electron energy-loss spectroscopy will tell us the elements found in very small amounts that were undetectable with XEDS. Electron-backscattered diffraction in the scanning electron microscope will give us phase information; the formation of certain precipitates can tell us a minimum temperature the melt must have reached. We will endeavor to obtain and publish these data, whatever they reveal.

The following photograph has become available, evidently showing the now-solidified metal with entrained material, stored (as of November 2005) in a warehouse in New York:

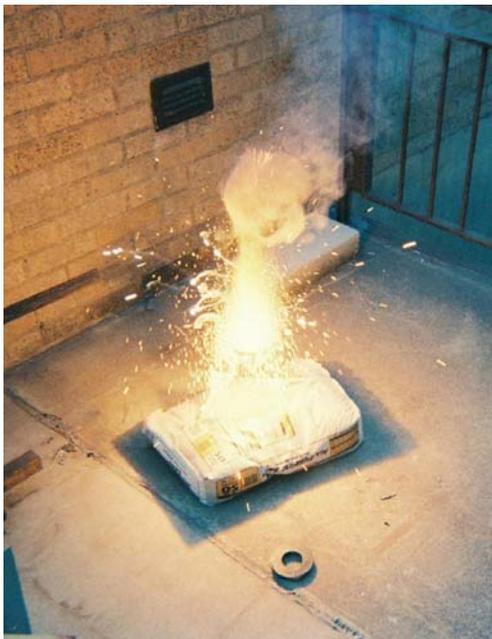
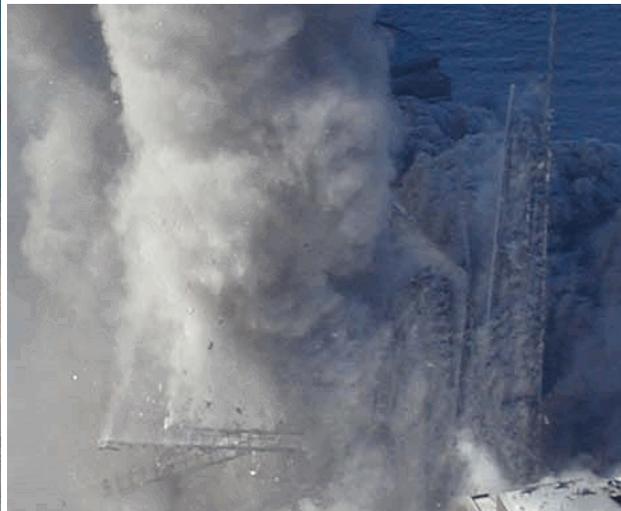
Mr. Miller captured two ladder-like structures in his photograph (lower left of the right-most photograph above; the photo now avoids problems of an earlier version which had contrast enhancement), consistent with steel structures observed in the core of WTC 1. Observe the grayish-white plumes trailing upward from white "blobs" at the left-most extremities of the upper structure. (The lower structure is mostly obscured by dust.) It is possible that thermite cut through structural steel and that what we now observe is white-hot iron from the reaction adhering to the severed ends of the steel, with grayish-white aluminum oxide still streaming away from the reaction sites. The observations are *consistent with the use of thermite or one of its variants*. However, further analysis of this and additional photographs from the series is necessary before any firm conclusions can be drawn about this line of evidence.

An intriguing photograph (below right) taken by Rob Miller, photojournalist with the New York Post, provides additional photographic evidence (Swanson, 2003) for the use of thermite or a sulfur-containing derivative such as thermate. We see debris and dust as WTC 1 collapses, with WTC 7 seen in the foreground, across the street from WTC 1. The photograph on the left shows, for comparison, the thermite reaction with a grayish-white aluminum-oxide dust plume extending from white-hot molten iron "blob" from the reaction. (Experiment at BYU by the author in which thermite-plus-sulfur cut through a steel cup in a fraction of a second. Any thermite reaction is a dangerous reaction and should only be performed by a trained professional capable of assessing the hazards and risks.)

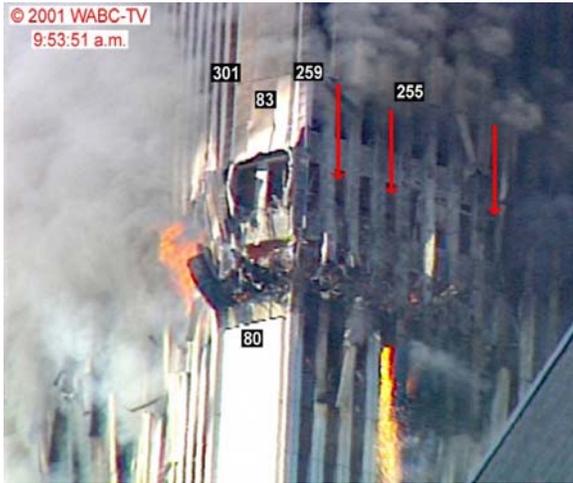
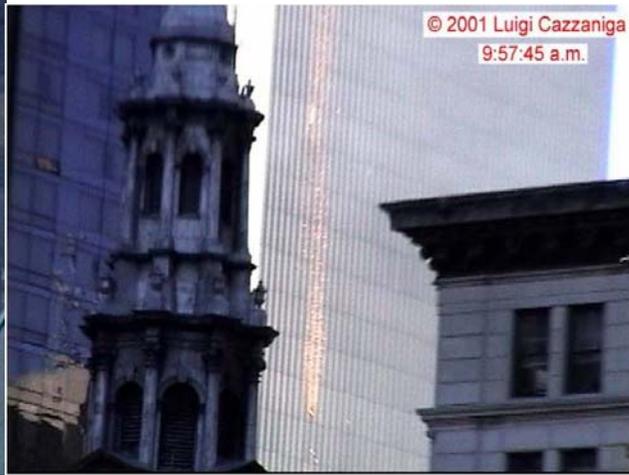
Who can deny that liquid, molten metal existed at the WTC disaster? The yellow color implies a molten-metal temperature of approximately 1000 °C, evidently above that which the dark-smoke hydrocarbon fires in the Towers could produce. If aluminum (e.g., from the plane) had melted, it would melt and flow away from the heat source at its melting point of about 650 °C and thus would not reach the yellow color observed for this molten metal. Thus, molten aluminum is already ruled out with high probability. But molten iron with the characteristics seen in this video is in fact consistent with a thermite-reaction attacking the steel columns in the Tower, thus weakening the building just prior to its collapse, since thermite produces molten iron at yellow-to-white hot temperatures. (As some of the molten metal hits the side of the building in the video clip above, the white-hot interior is evidently exposed as the metal "splashes".) Also, the fact that the liquid metal retains an orange hue as it nears the ground (right photograph) further rules out aluminum, and suggests a mid-flight thermite reaction (typical of thermite). The reader may wish to compare the dripping molten metal observed on the corner of the South Tower just before its collapse with the dripping molten metal from known thermite reactions: <http://www.checktheevidence.com/911/Thermite2.htm> (backup available here: <http://www.veronicachapman.com/checktheevidence/Thermite.htm> )

Dramatic footage reveals yellow-to-white hot molten metal dripping from the South WTC Tower just minutes before its collapse: <http://video.google.com/videoplay?docid=-2991254740145858863&q=cameraplanet+9%2F11>. Photographs capture the same significant event, clearly showing liquid metal dropping from the South Tower, still hot as it nears the ground below:

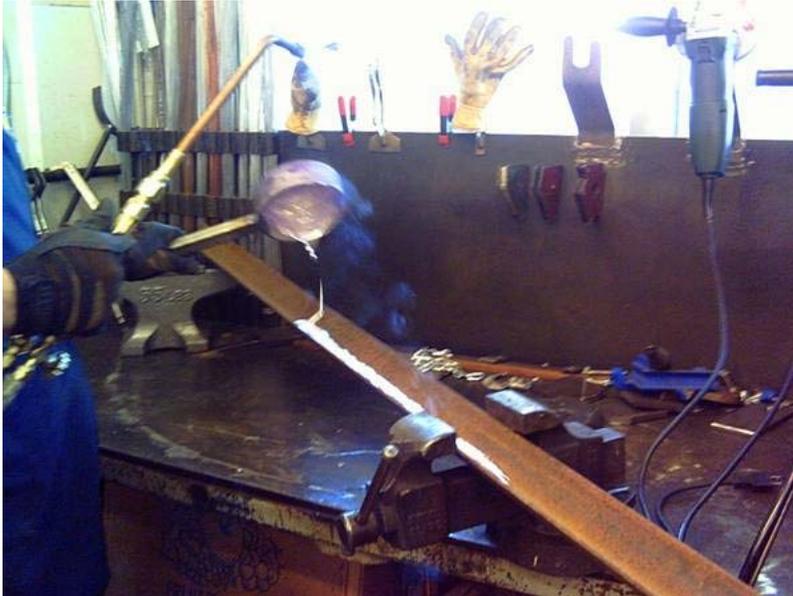
Molten aluminum poured onto rusted steel: no violent reactions observed at all.

We also noted that while a steel pan holding the aluminum glowed red and then yellow hot, the molten aluminum inside retained its silvery-gray color, adding significantly to the evidence that the yellow-white molten metal dripping from the South Tower shortly before its collapse was NOT molten aluminum. (Recall also that the yellow color of the molten metal (video clip above) implies a temperature of approximately 1100 °C -- too high for the dark-smoke hydrocarbon fires burning in the building.) This is point worth emphasizing: aluminum has low emissivity and high reflectivity, so that in daylight conditions molten aluminum will appear silvery-gray, while molten iron (with its characteristic high emissivity) will appear yellow-white (at ~1100 °C) as observed in the molten metal dripping from the South Tower just before its collapse (see <http://www.veronicachapman.com/checktheevidence/Thermite.htm>).

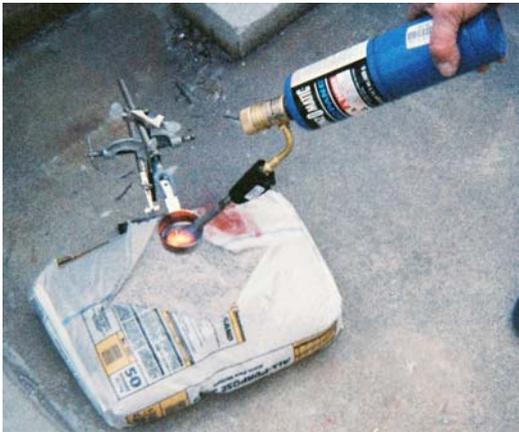
Thermite did not ignite when heated with a propane torch.

It is important to note that initiating the thermite reaction requires temperatures well above those achieved by burning jet fuel or office materials -- which is an advantage of using thermite charges over conventional monomolecular explosives such as TNT, RDX and PETN. Below is a photograph of an experiment performed by the author and colleagues at BYU in which a sample of thermite was heated to orange-hot temperature (about 1700 °F). We demonstrated that the thermite reaction would not ignite at this high temperature. Later, the thermite reaction was triggered by burning a magnesium strip in contact with the thermite. An electrical superthermite "match" could have been used and remotely triggered via radio signal.

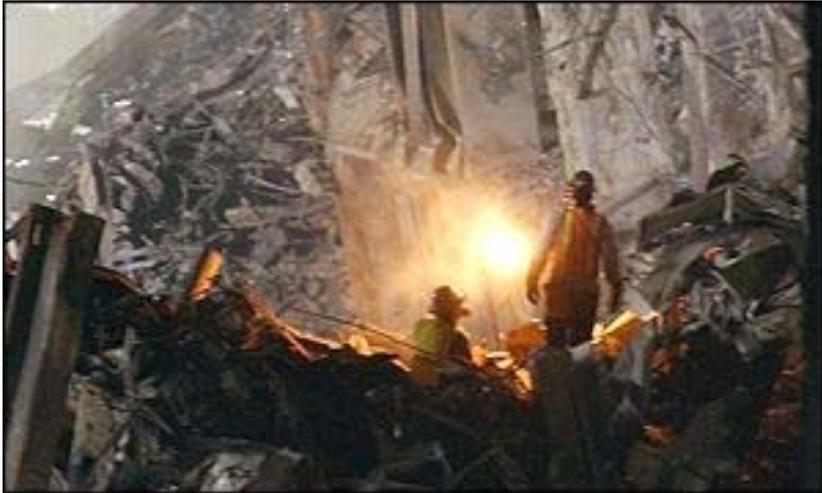
Peering into the yellow-white hot "core" under the WTC rubble. <http://news.bbc.co.uk/2/>[hi/science/nature/1858491.stm](http://science.nature/1858491.stm)

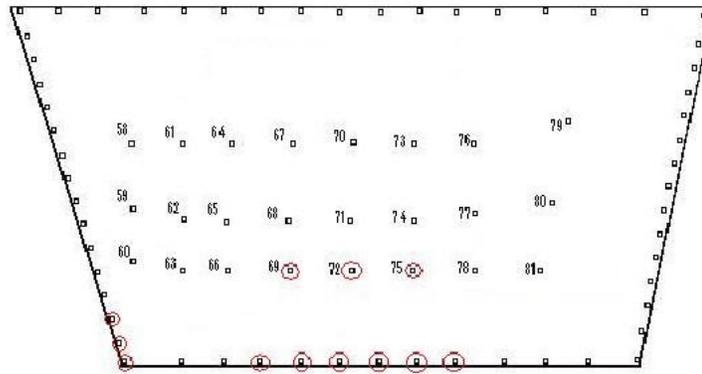
Diagram showing steel-column arrangement in WTC 7, view looking down on the roof. Circled columns were possibly damaged due to debris from WTC 1 collapse, some 350 feet away (NIST, 2005) so the damage was clearly non-symmetrical, and evidently, none of the core columns was severed by falling debris. WTC 7 was never hit by a plane.

As you observed (link above), WTC 7 collapsed rapidly and nearly-straight-down symmetrically -- even though fires were randomly scattered in the building. WTC 7 fell about seven hours after the Towers collapsed, even though no major persistent fires were visible (considerable dark smoke was seen). There were twenty-four huge steel support columns inside WTC 7 as well as huge trusses, arranged non-symmetrically, along with some fifty-seven perimeter columns, as indicated in the diagram below (FEMA, 2002, chapter 5; NIST, 2005).

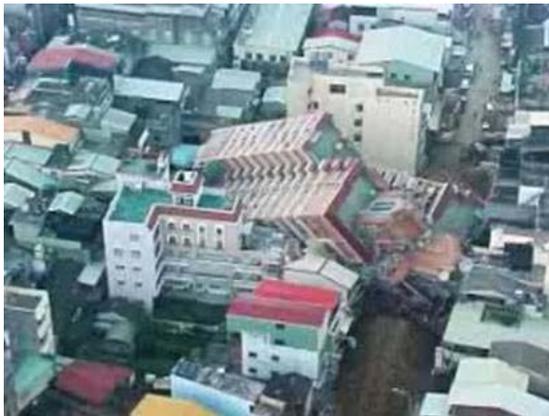
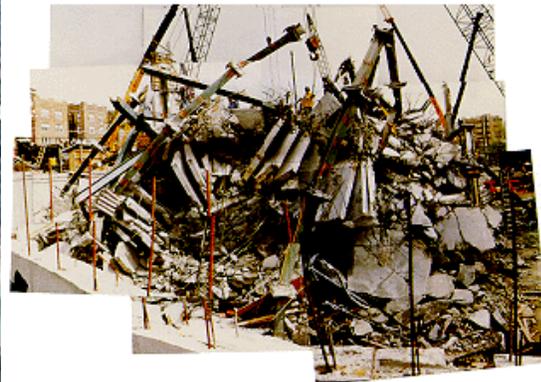
Non-symmetrical collapse of tall buildings when due to random causes. L'Ambiance Plaza collapse (right) shows how pancaked concrete floor slabs are largely intact and clearly reveal stacking effects with minimal fine dust, as expected from random progressive collapse. By contrast, concrete floors in the Twin Towers and WTC 7 were pulverized to dust -- as is common in controlled demolitions using explosives.

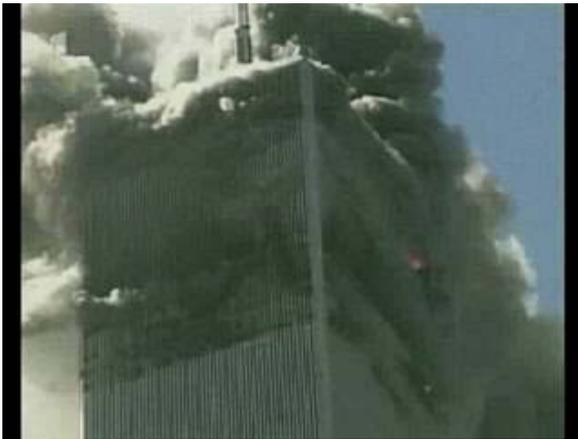
North Tower showing antenna (top) at beginning of collapse.

Review of videotape recordings of the collapse taken from various angles indicates that the transmission tower on top of the structure began to move downward and laterally slightly before movement was evident at the exterior wall. This suggests that **collapse began with one or more failures in the central core area of the building**. (FEMA, 2002, chapter 2; emphasis added.)

Yes, we can see for ourselves that the antenna drops first from videos of the North Tower collapse. (See [http://911research.wtc7.net/wtc/evidence/videos/wtc1\\_close\\_frames.html](http://911research.wtc7.net/wtc/evidence/videos/wtc1_close_frames.html); also <http://home.comcast.net/~skydrifter/collapse.htm>.) A NY Times article also notes this behavior:

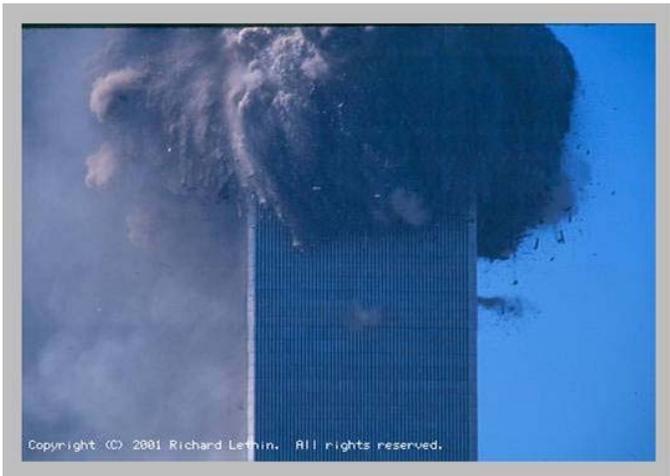
North Tower during top-down collapse.  
Notice mysterious horizontal plumes far below pulverization region.

The horizontal ejection of structural steel members for hundreds of feet and the pulverization of concrete to flour-like powder, observed clearly in the collapses of the WTC towers, provide further evidence for the use of explosives – as well-explained in <http://911research.wtc7.net/talks/towers/index.html>. (See also, Griffin, 2004, chapter 2.) The observed plumes or "squibs" are far below the pulverization region and therefore deserving of particular attention. They appear much like the plumes observed in <http://www.implosionworld.com/cinema.htm> (e.g., the controlled demolition of the Southwark Towers).

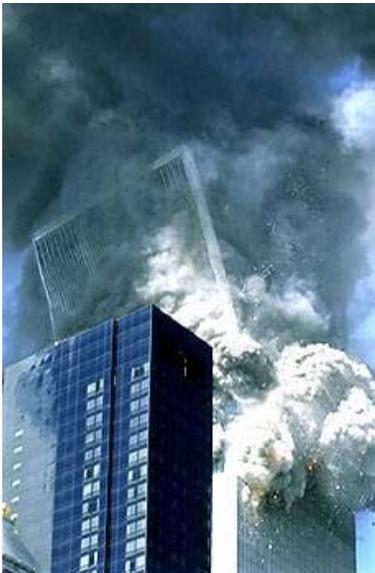
Top ~ 30 floors of South Tower topple over.  
What happens to the block and its angular momentum?

We observe that approximately 30 upper floors begin to rotate as a block, to the south and east. They begin to topple over, not fall straight down. The torque due to gravity on this block is enormous, as is its angular momentum. But then – and this I'm still puzzling over – this block turned mostly to powder *in mid-air*! How can we understand this strange behavior, without explosives? Remarkable, amazing – and demanding scrutiny since the US government-funded reports failed to analyze this phenomenon. But, of course, the Final NIST 9-11 report "**does not actually include the structural behavior of the tower after the conditions for collapse initiation were reached.**" (NIST, 2005, p. 80, fn. 12; emphasis added.)

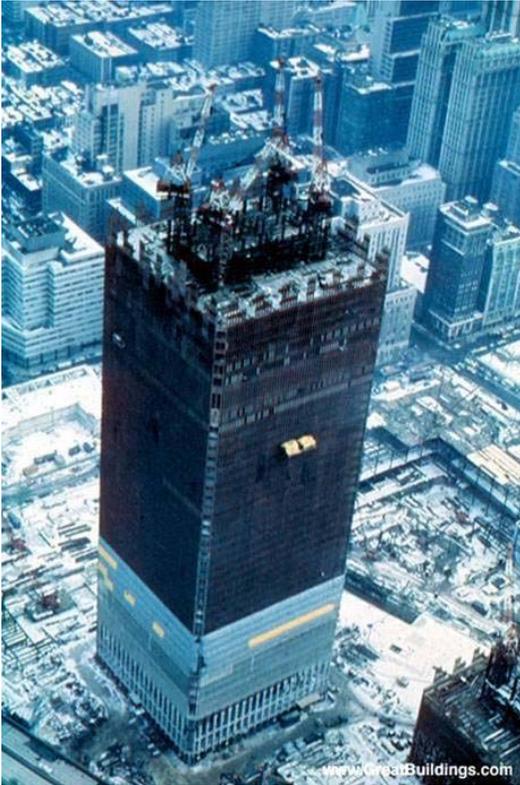
The WTC towers were solidly constructed with 47 steel core columns and 240 perimeter steel columns. 287 steel-columns total. Many doubt that random fires/damage could cause them to collapse straight down (official theory), and suspect explosives.

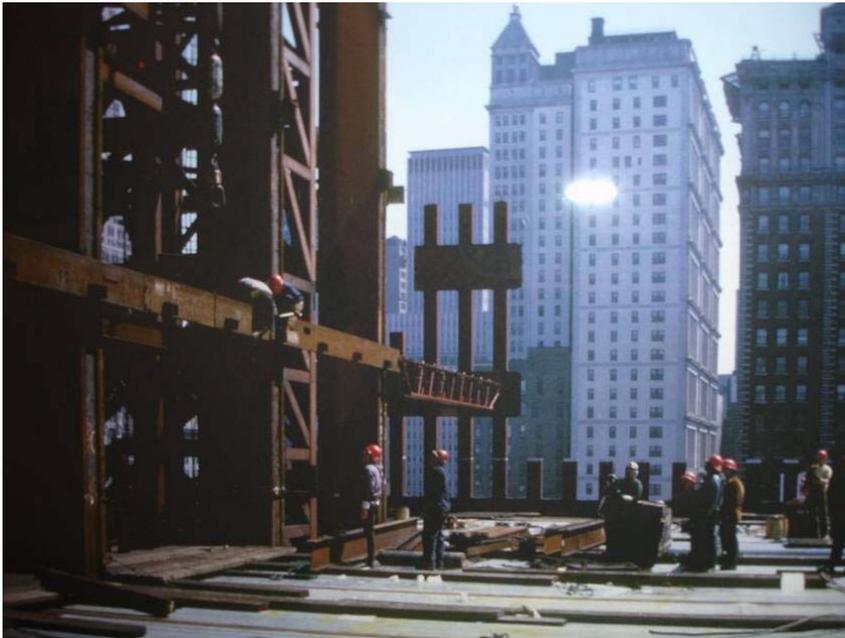
Steel-frame: Huge core (left) is an enormous heat sink. Notice workers standing on floor pan which is firmly attached to the interconnected core columns.
